**Flood Control Project Maintenance
Levee Inspections**

2019 Channel Summary Report

San Joaquin County Flood Control and Water Conservation District

Levee Inspection Report By Mile - Channel 2019

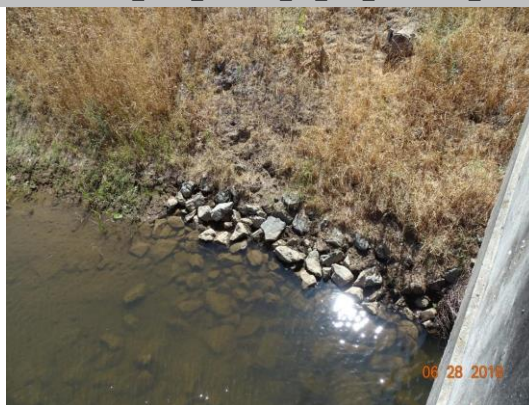
Photo 2 of 2 : CH_2019_NA0017_44_151_20190611_00047.jpg

Rating **	A	Issue No.	151 (cont)	GPS Lat/Long
Issue Type +	Ma	Location *		37.895050 °
Category	Rivers, Channels & Designated Flood			-121.118200 °
Item	Revetments			
DWR ID	DWR_NA0017_44_c_2016_151

View of the revetments on the upstream of the channel. Summer 2018

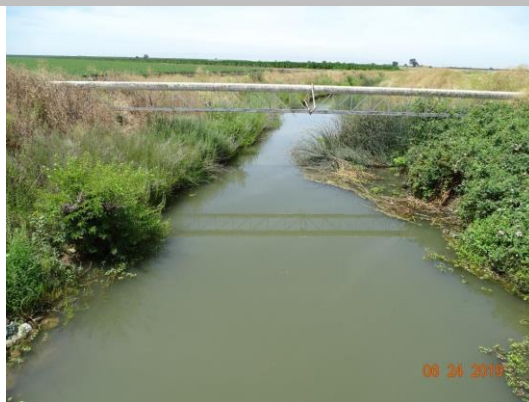
Photo 1 of 2 : CH_2019_NA0017_44_56_20190718_00073.jpg

Inspector Comments: There is minor vegetation in the channel, but the flow is not likely impeded.

View of vegetation looking downstream. Summer 2019

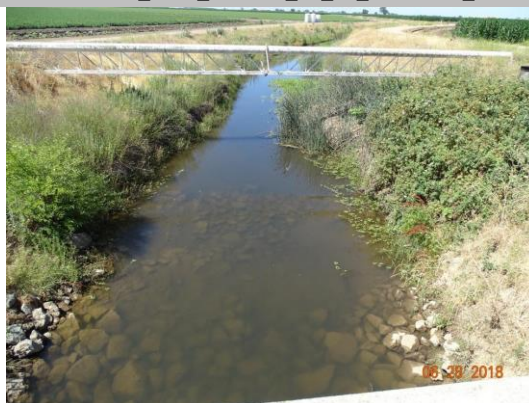
Photo 2 of 2 : CH_2019_NA0017_44_56_20190611_00018.jpg

Rating **	A	Issue No.	56 (cont)	GPS Lat/Long
Issue Type +	Ma	Location *		37.895050 °
Category	Rivers, Channels & Designated Flood			-121.118200 °
Item	Vegetation & Obstructions			
DWR ID	DWR_NA0017_44_c_2012_56

View of the channel looking downstream. Summer 2018

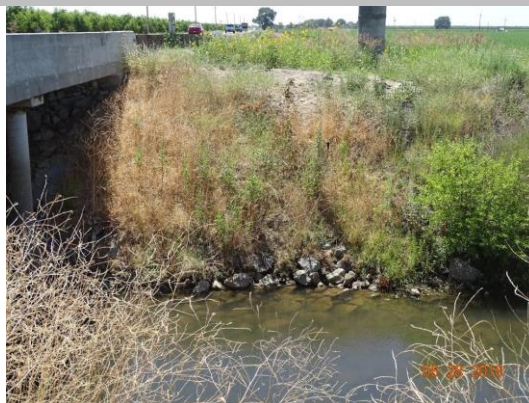
Photo 2 of 3 : CH_2019_NA0017_44_59_20190611_00019.jpg

Inspector Comments: Existing riprap is visible, however there are area of sloughing with displaced or missing riprap near the top of the left bank.

View of existing revetments on the channel banks looking downstream.
Summer 2018

Rating **	M	Issue No.	59 (cont)	GPS Lat/Long
Issue Type +	Ma	Location *		37.895050 °
Category	Rivers, Channels & Designated Flood			-121.118200 °
Item	Revetments			
DWR ID	DWR_NA0017_44_c_2012_59

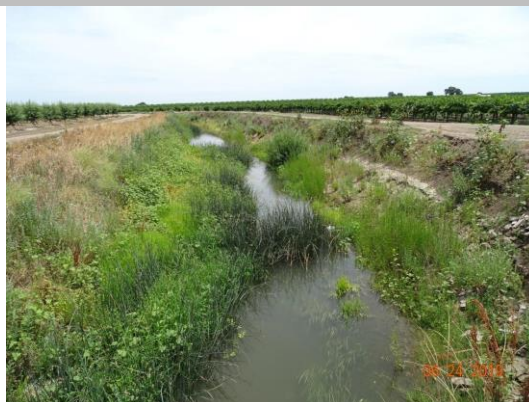
Photo 1 of 1 : CH_2019_NA0017_44_61_20190718_00075.jpg

Rating **	A	Issue No.	61	GPS Lat/Long
Issue Type +	Ma	Location *		37.880726 °
Category	Rivers, Channels & Designated Flood			-121.146929 °
Item	Vegetation & Obstructions			
DWR ID	DWR_NA0017_44_c_2012_61			
Action/Comments				
Inspector Comments: There is minor vegetation within the channel, but the flow is not likely to be impeded.

View of vegetation looking upstream. Summer 2019

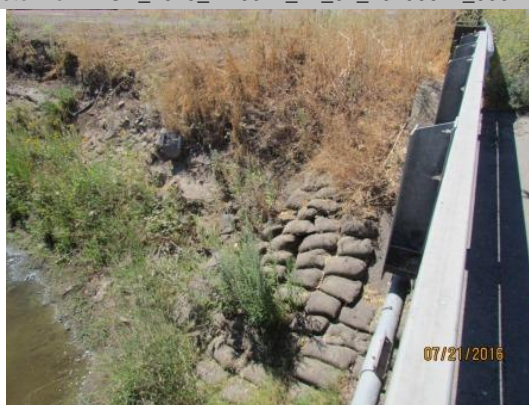
Photo 2 of 2 : CH_2019_NA0017_44_64_20190611_00022.jpg

View of existing riprap on the upstream of the channel.

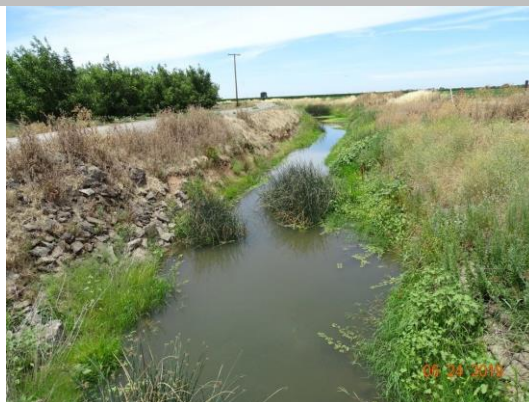
Photo 1 of 2 : CH_2019_NA0017_44_66_20190718_00077.jpg

Inspector Comments: There is minor vegetation within the channel, but the flow is not likely to be impeded.

View of vegetation looking downstream. Summer 2019

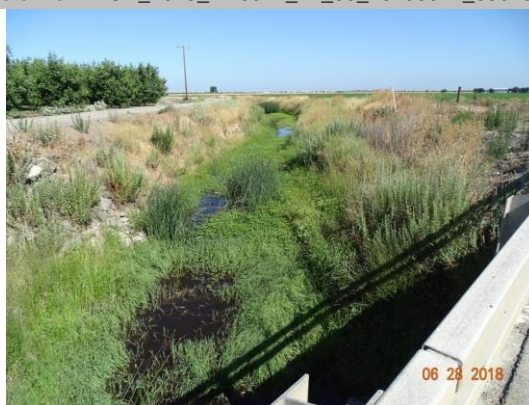
Photo 2 of 2 : CH_2019_NA0017_44_66_20190611_00023.jpg

Rating **	A	Issue No.	66 (cont)	GPS Lat/Long
Issue Type +	Ma	Location *		37.880726 °
Category	Rivers, Channels & Designated Flood			-121.146929 °
Item	Vegetation & Obstructions			
DWR ID	DWR_NA0017_44_c_2012_66

View of the channel looking downstream. Summer 2018

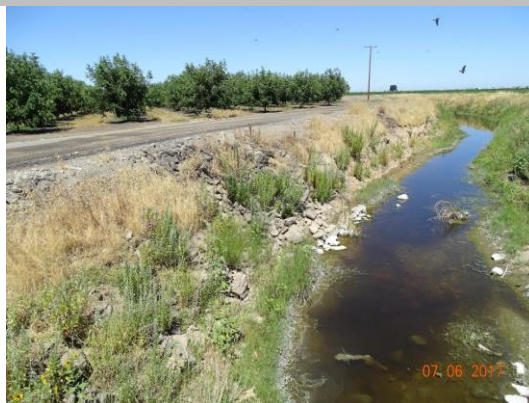
Photo 2 of 2 : CH_2019_NA0017_44_69_20190611_00024.jpg

Inspector Comments: There is minor erosion on the left bank that should be monitored or repaired.

View of the existing riprap on the channel bank looking downstream.

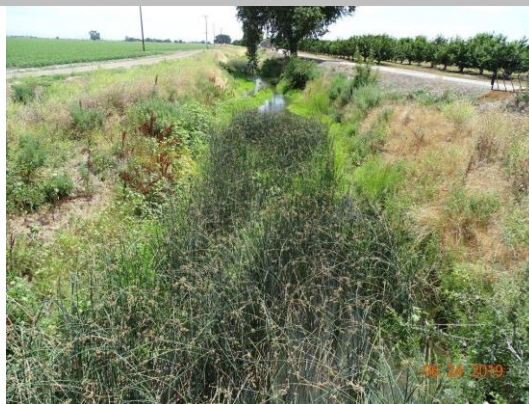
Photo 1 of 2 : CH_2019_NA0017_44_71_20190718_00079.jpg

Inspector Comments: There is vegetation within the channel which may impede the flow.

View of vegetation looking upstream. Summer 2019

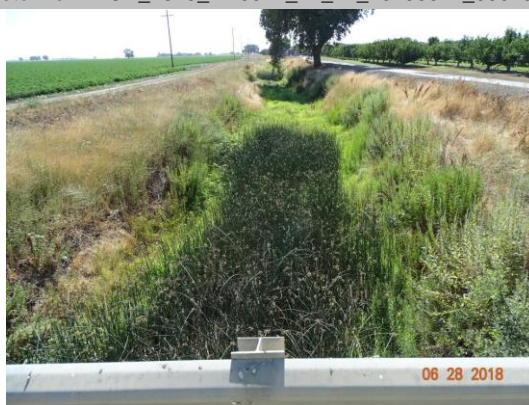
Photo 2 of 2 : CH_2019_NA0017_44_71_20190611_00025.jpg

View of vegetation on the upstream side of the channel. Summer 2018

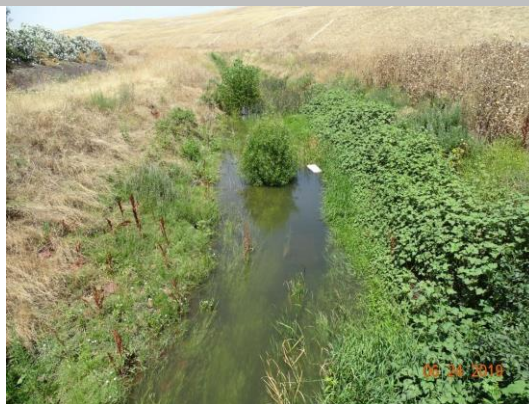
Photo 1 of 2 : CH_2019_NA0017_44_76_20190718_00080.jpg

Inspector Comments: There is vegetation within the channel which may impede the flow.

View of vegetation looking downstream. Summer 2019

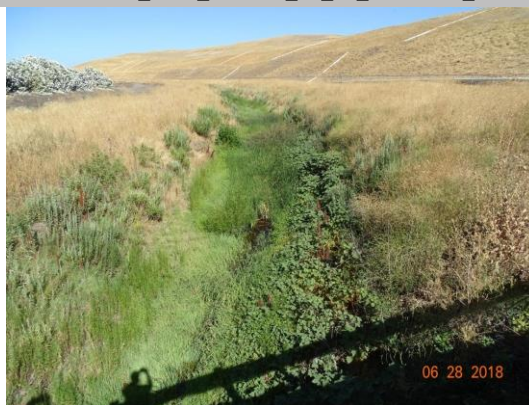
Photo 2 of 2 : CH_2019_NA0017_44_76_20190611_00026.jpg

Rating **	M	Issue No.	76 (cont)	GPS Lat/Long
Issue Type +	Ma	Location *		37.872720 °
Category	Rivers, Channels & Designated Flood			-121.183100 °
Item	Vegetation & Obstructions			
DWR ID	DWR_NA0017_44_c_2012_76

View of the vegetation on the downstream end of the channel. Summer 2018

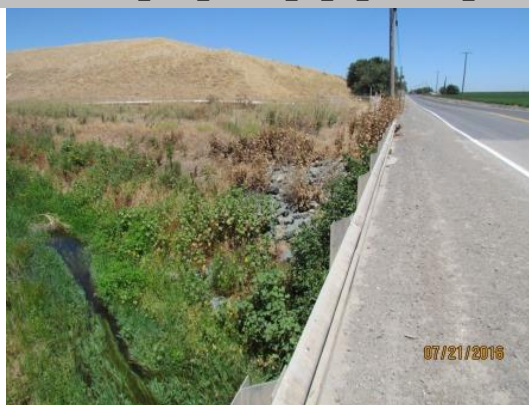
Photo 1 of 1 : CH_2019_NA0017_44_79_20190611_00027.jpg

Inspector Comments: Riprap is visible and appears to be undamaged.

View of the revetments on the downstream of the channel.

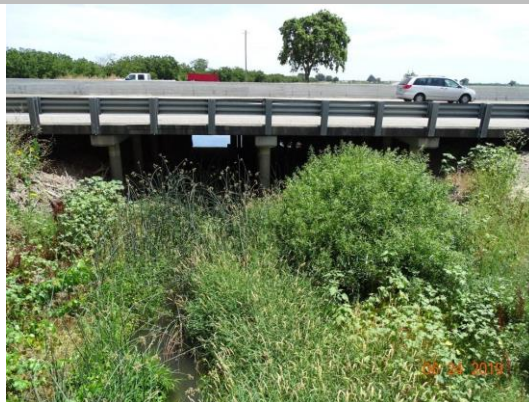
Photo 1 of 2 : CH_2019_NA0017_44_81_20190718_00081.jpg

Inspector Comments: There is vegetation within the channel which may impede the flow.

View of vegetation upstream of Hwy. 99. Summer 2019

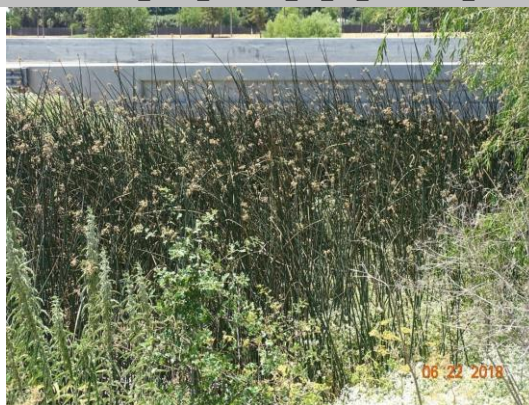
Photo 2 of 2 : CH_2019_NA0017_44_81_20190611_00028.jpg

View of vegetation on the upstream of the channel. Summer 2018

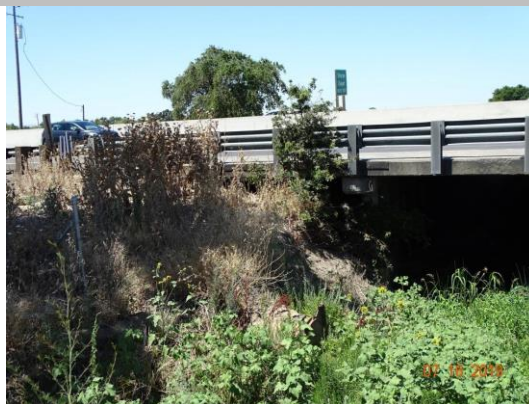
Photo 1 of 2 : CH_2019_NA0017_44_83_20190718_00082.jpg

Rating **	M	Issue No.	83 (cont)	GPS Lat/Long
Issue Type +	Ma	Location *		37.872077 °
Category	Rivers, Channels & Designated Flood			-121.219318 °
Item	Erosion / Bank Caving			
DWR ID	DWR_NA0017_44_c_2012_83

View of pipe outlet on left bank, upstream of Hwy 99. Summer 2019

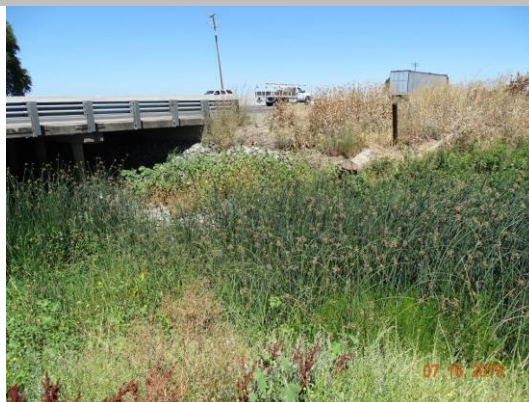
Photo 1 of 2 : CH_2019_NA0017_44_84_20190718_00083.jpg

Rating **	A	Issue No.	84	GPS Lat/Long
Issue Type +	Ma	Location *		37.872077 °
Category	Rivers, Channels & Designated Flood			-121.219318 °
Item	Revetments			
DWR ID	DWR_NA0017_44_c_2012_84			
Action/Comments

View of existing revetments on right bank upstream of Hwy 99. Summer 2019

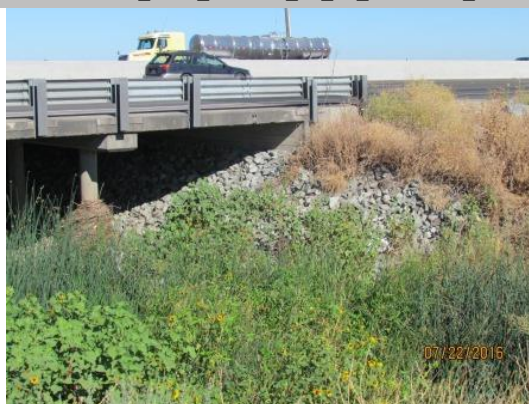
Photo 2 of 2 : CH_2019_NA0017_44_84_20190611_00032.jpg

View of the existing revetments on the upstream end of the channel.

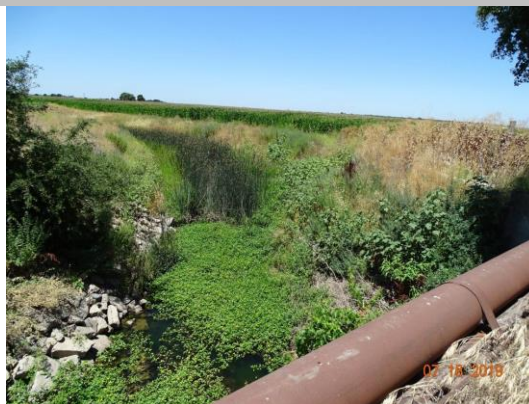
Photo 1 of 2 : CH_2019_NA0017_44_86_20190722_00089.jpg

Rating **	M	Issue No.	86	GPS Lat/Long
Issue Type +	Ma	Location *		37.872077 °
Category	Rivers, Channels & Designated Flood			-121.219318 °
Item	Vegetation & Obstructions			
DWR ID	DWR_NA0017_44_c_2012_86			
Action/Comments				
Inspector Comments: There is vegetation within the channel which may impede the flow.

View of vegetation looking downstream of channel. Summer 2019

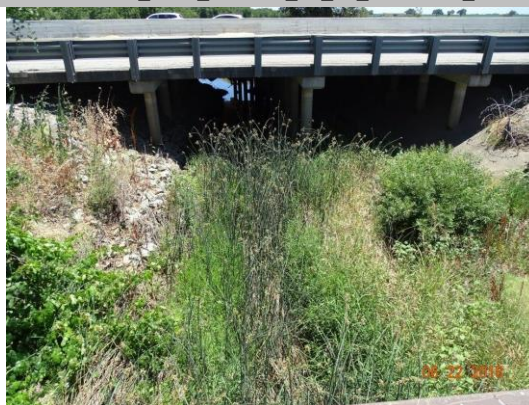
Photo 2 of 2 : CH_2019_NA0017_44_86_20190611_00033.jpg

View of the vegetation on the downstream side of the channel. Summer 2018

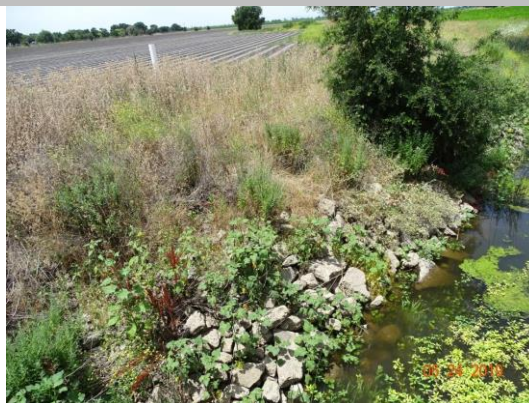
Photo 1 of 2 : CH_2019_NA0017_44_89_20190718_00085.jpg

Rating **	A	Issue No.	89	GPS Lat/Long
Issue Type +	Ma	Location *		37.872077 °
Category	Rivers, Channels & Designated Flood			-121.219318 °
Item	Revetments			
DWR ID	DWR_NA0017_44_c_2012_89			
Action/Comments				
Inspector Comments: Riprap is visible and appears to be undamaged.

View of revetments on left bank looking downstream. Summer 2019

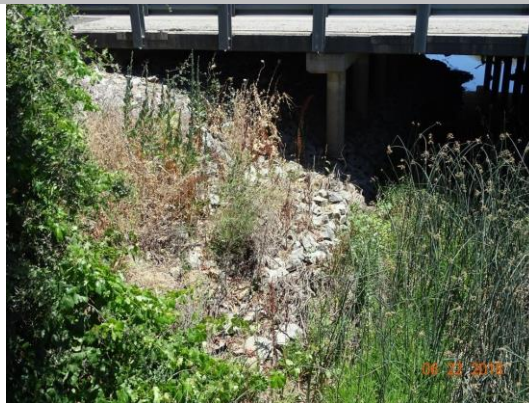
Photo 2 of 2 : CH_2019_NA0017_44_89_20190611_00035.jpg

Rating **	A	Issue No.	89 (cont)	GPS Lat/Long
Issue Type +	Ma	Location *		37.872077 °
Category	Rivers, Channels & Designated Flood			-121.219318 °
Item	Revetments			
DWR ID	DWR_NA0017_44_c_2012_89

View of the existing revetments on the downstream of the channel.
Summer 2018

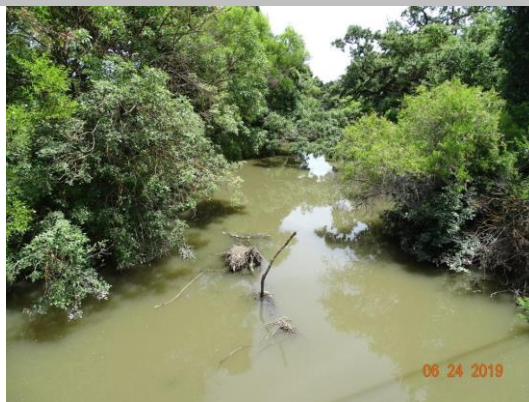
Photo 1 of 3 : CH_2019_NA0017_44_120_20190718_00086.jpg

Rating **	A	Issue No.	120	GPS Lat/Long
Issue Type +	Ma	Location *		37.894480 °
Category	Rivers, Channels & Designated Flood			-121.275977 °
Item	Vegetation & Obstructions			
DWR ID	DWR_NA0017_44_c _ 2014_120			
Action/Comments				
Inspector Comments: There is minimal vegetation within the channel, the flow may not be impeded.

View of vegetation looking upstream. Summer 2019

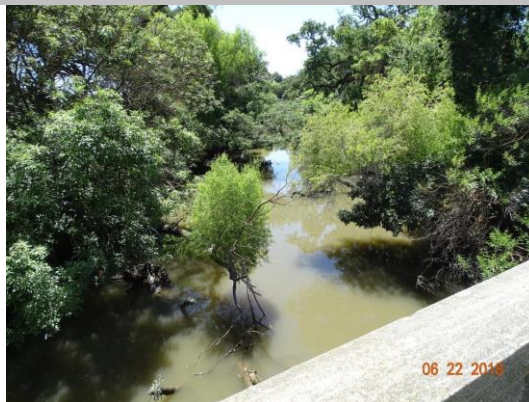
Photo 2 of 3 : CH_2019_NA0017_44_120_20190611_00040.jpg

View of the channel looking upstream. Summer 2018

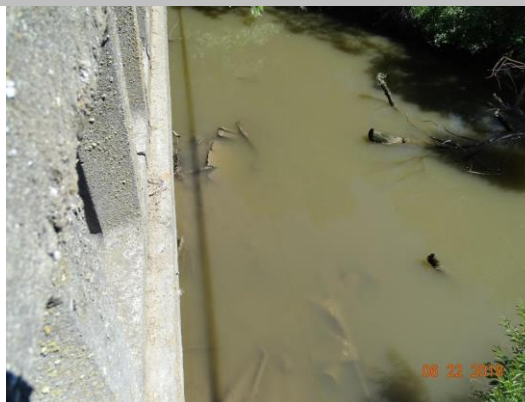
Photo 3 of 3 : CH_2019_NA0017_44_120_20190611_00041.jpg

Inspector Comments: There is minimal vegetation within the channel, the flow may not be impeded.

View of the debris in the water looking upstream. Summer 2018

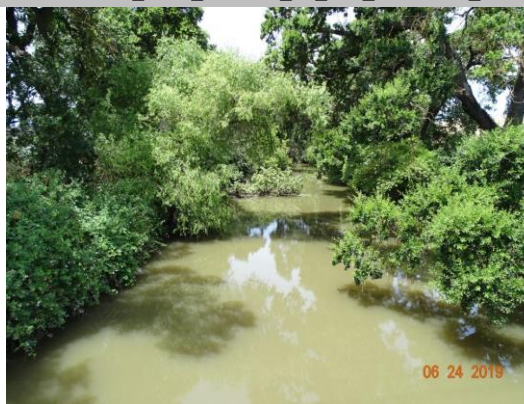
Photo 1 of 1 : CH_2019_NA0017_44_125_20190718_00087.jpg

Inspector Comments: There is minimal vegetation within the channel, flow is not likely to be impeded.

View of vegetation looking downstream. Summer 2019

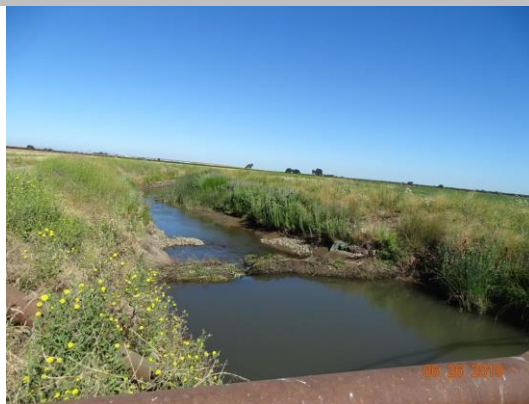
Photo 1 of 2 : CH_2019_NA0017_45_6_20190715_00034.jpg

Rating **	A	Issue No.	6	GPS Lat/Long
Issue Type +	Ma	Location *		37.888860 °
Category	Rivers, Channels & Designated Flood			-121.130320 °
Item	Vegetation & Obstructions			
DWR ID	DWR_NA0017_45_c_2012_6			
Action/Comments				
Inspector Comments: There is a minimal obstruction approximately 100 feet downstream of confluence, however the flow is not impeded.

View of partial obstruction in channel looking downstream of confluence. Summer 2019

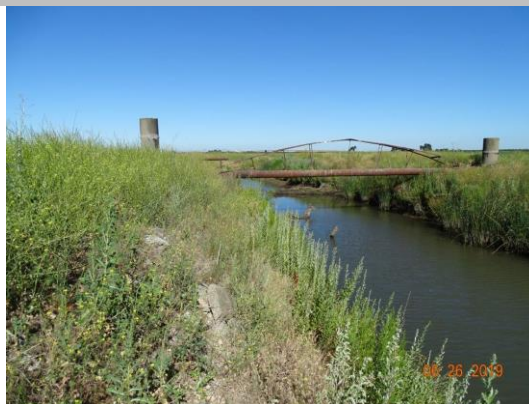
Photo 2 of 2 : CH_2019_NA0017_45_6_20190715_00035.jpg

View of confluence looking downstream. Summer 2019

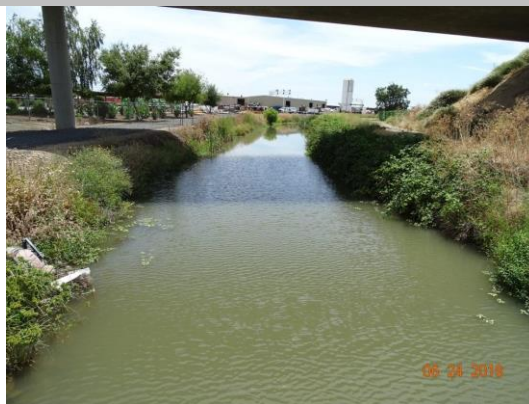
Photo 1 of 1 : CH_2019_NA0017_45_11_20190715_00036.jpg

Rating **	A	Issue No.	11	GPS Lat/Long
Issue Type +	Ma	Location *		37.889520 °
Category	Rivers, Channels & Designated Flood			-121.146980 °
Item	Vegetation & Obstructions			
DWR ID	DWR_NA0017_45_c_2012_11			
Action/Comments				
Inspector Comments: There is minimal vegetation within the channel, flow is not likely to be impeded.

View of channel looking upstream. Summer 2019

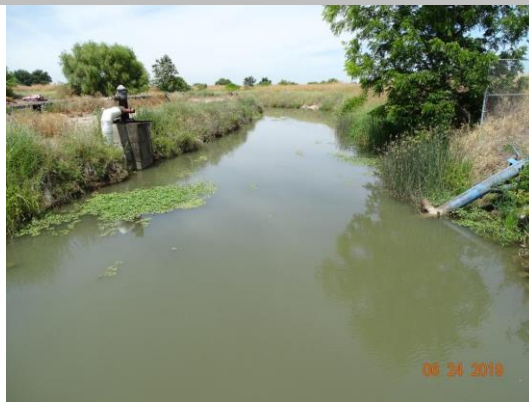
Photo 1 of 1 : CH_2019_NA0017_45_16_20190715_00037.jpg

Inspector Comments: There is minimal vegetation within the channel, flow is not likely to be impeded.

View of channel looking downstream. Summer 2019

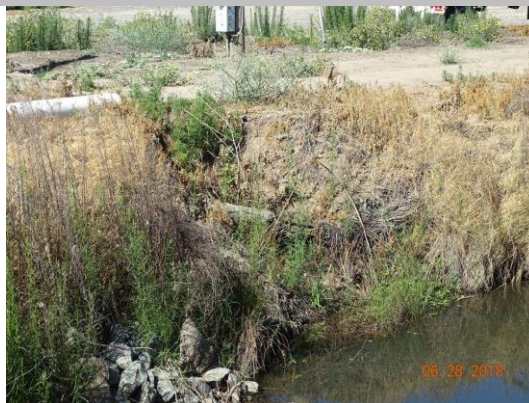
Photo 2 of 2 : CH_2019_NA0017_45_18_20190612_00005.jpg

Rating **	M	Issue No.	18 (cont)	GPS Lat/Long
Issue Type +	Ma	Location *		37.889520 °
Category	Rivers, Channels & Designated Flood			-121.146980 °
Item	Erosion / Bank Caving			
DWR ID	DWR_NA0017_45_c_2012_18

View of bank erosion on the downstream of the channel. Summer 2018

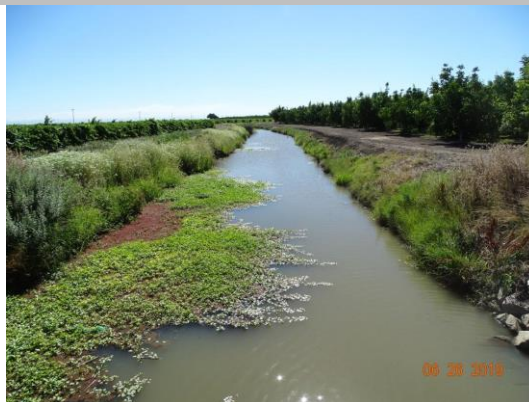
Photo 1 of 1 : CH_2019_NA0017_45_21_20190715_00038.jpg

Inspector Comments: There is minimal vegetation within the channel, flow is not likely to be impeded.

View of channel looking upstream. Summer 2019

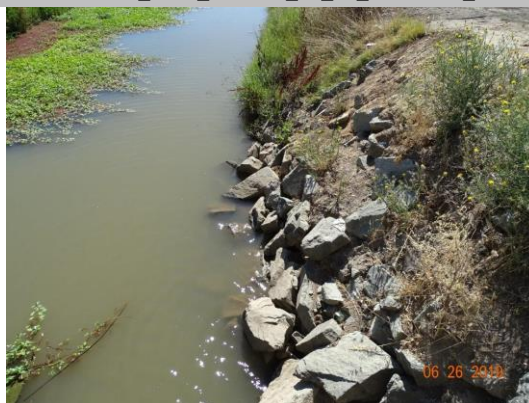
Photo 1 of 1 : CH_2019_NA0017_45_24_20190715_00039.jpg

Rating **	A	Issue No.	24	GPS Lat/Long
Issue Type +	Ma	Location *		37.886056 °
Category	Rivers, Channels & Designated Flood			-121.183664 °
Item	Revetments			
DWR ID	DWR_NA0017_45_c_2012_24			
Action/Comments				
Inspector Comments: Riprap is visible and appears to be undamaged.

View looking upstream of revetments on left bank. Summer 2019

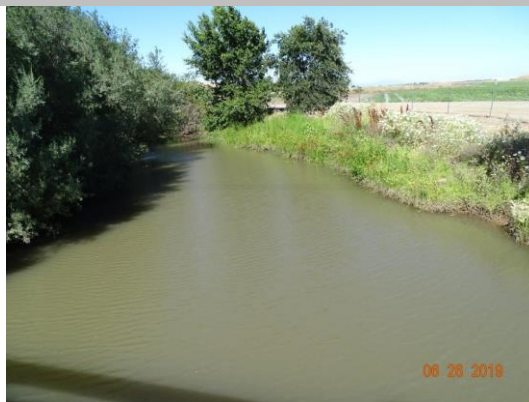
Photo 1 of 1 : CH_2019_NA0017_45_26_20190715_00040.jpg

Check Point / View				
Austin Rd / Down				
Rating **	A	Issue No.	26	GPS Lat/Long
Issue Type +	Ma	Location *		37.886056 °
Category	Rivers, Channels & Designated Flood			-121.183664 °
Item	Vegetation & Obstructions			
DWR ID	DWR_NA0017_45_c_2012_26			
Action/Comments				
Inspector Comments: There is minimal vegetation within the channel, flow is not likely to be impeded.

View of channel looking downstream. Summer 2019

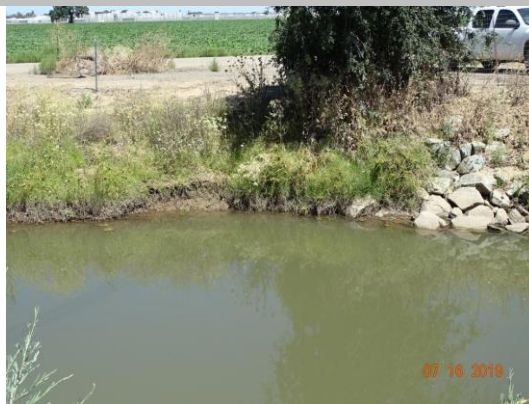
Photo 1 of 2 : CH_2019_NA0017_45_28_20190723_00052.jpg

Inspector Comments: There is erosion on the right bank of the channel.

View of erosion on right bank of channel. Summer 2019

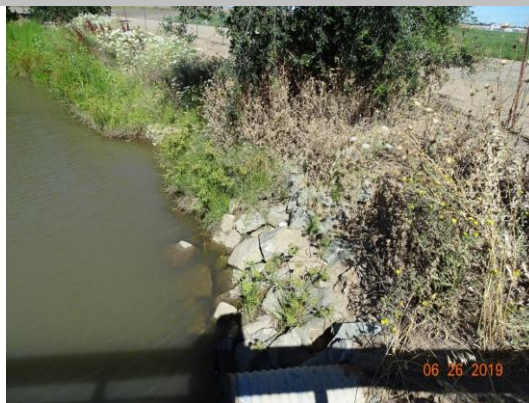
Photo 1 of 1 : CH_2019_NA0017_45_29_20190709_00027.jpg

Inspector Comments: Riprap is visible and appears to be undamaged.

View looking downstream of revetment on right bank. Summer 2019

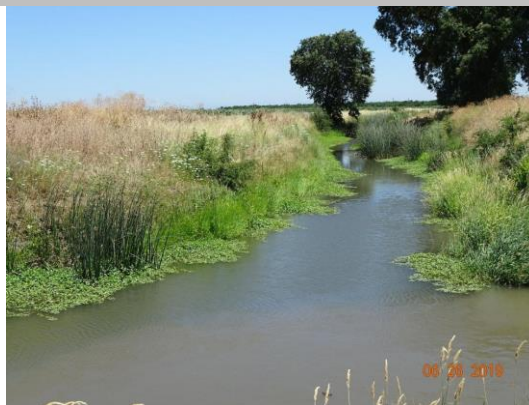
Photo 1 of 1 : CH_2019_NA0017_45_31_20190709_00028.jpg

Check Point / View				
Confluence at Airport Way / Up				
Rating **	A	Issue No.	31	GPS Lat/Long
Issue Type +	Ma	Location *		37.876513 °
Category	Rivers, Channels & Designated Flood			-121.236231 °
Item	Vegetation & Obstructions			
DWR ID	DWR_NA0017_45_c_2012_31			
Action/Comments				
Inspector Comments: There is minimal vegetation within the channel, flow is not likely to be impeded.

View of confluence looking upstream. Summer 2019

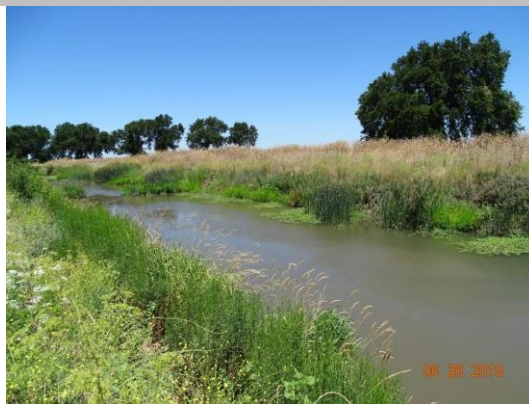
Photo 1 of 1 : CH_2019_NA0017_45_36_20190709_00029.jpg

Rating **	A	Issue No.	36	GPS Lat/Long
Issue Type +	Ma	Location *		37.876513 °
Category	Rivers, Channels & Designated Flood			-121.236231 °
Item	Vegetation & Obstructions			
DWR ID	DWR_NA0017_45_c_2012_36			
Action/Comments				
Inspector Comments: There is minimal vegetation within the channel, flow is not likely to be impeded.

View of channel looking downstream. Summer 2019

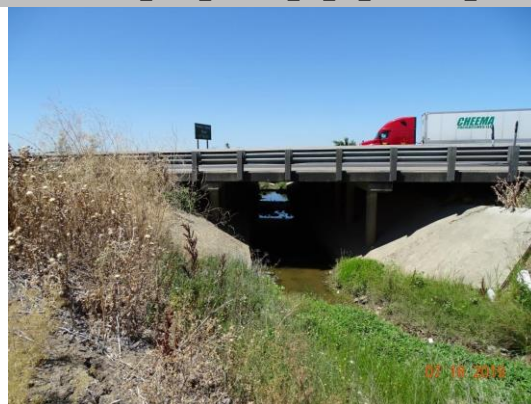
Photo 1 of 2 : CH_2019_NA0017_45_41_20190718_00044.jpg

Inspector Comments: There is minimal vegetation within the channel, flow is not likely to be impeded.

View of vegetation upstream from Hwy 99. Summer 2019

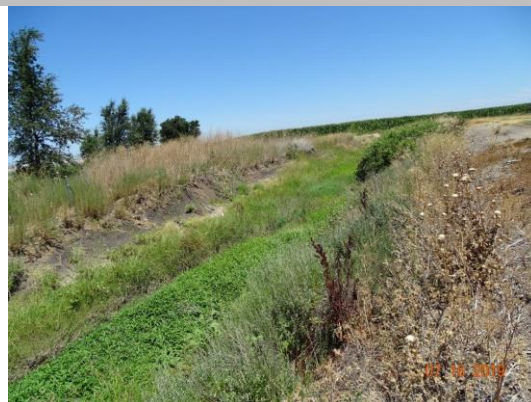
Photo 2 of 2 : CH_2019_NA0017_45_41_20190718_00046.jpg

Rating **	A	Issue No.	41 (cont)	GPS Lat/Long
Issue Type +	Ma	Location *		37.875127 °
Category	Rivers, Channels & Designated Flood			-121.219201 °
Item	Vegetation & Obstructions			
DWR ID	DWR_NA0017_45_c_2013_41			
Action/Comments				
Inspector Comments: There is minimal vegetation within the channel, flow is not likely to be impeded.

View of vegetation upstream from Hwy 99. Summer 2019

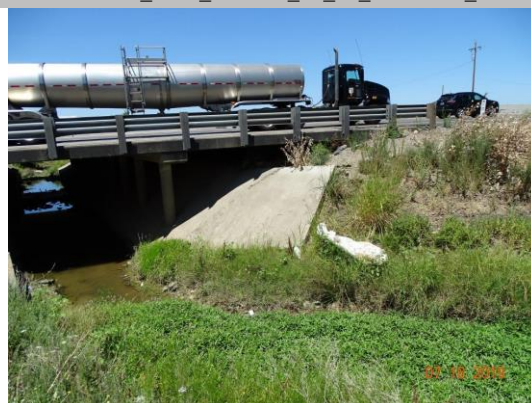
Photo 1 of 1 : CH_2019_NA0017_45_43_20190718_00047.jpg

Rating **	A	Issue No.	43	GPS Lat/Long
Issue Type +	Ma	Location *		37.875127°
Category	Rivers, Channels & Designated Flood			-121.219201°
Item	Revetments			
DWR ID	DWR_NA0017_45_c_2013_43			
Action/Comments				
Inspector Comments: Riprap is visible and appears to be undamaged.

View of revetments on right bank upstream of Hwy 99. Summer 2019

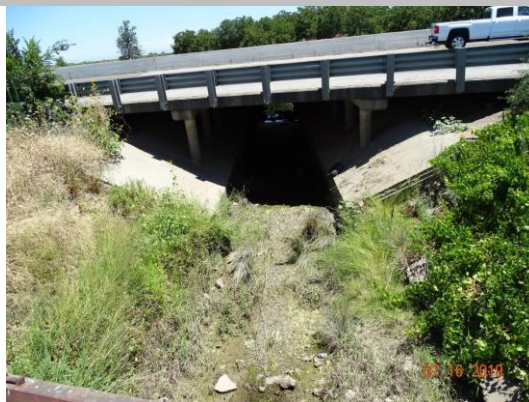
Photo 1 of 3 : CH_2019_NA0017_45_45_20190718_00048.jpg

Rating **	A	Issue No.	45	GPS Lat/Long
Issue Type +	Ma	Location *		37.875127 °
Category	Rivers, Channels & Designated Flood			-121.219201 °
Item	Vegetation & Obstructions			
DWR ID	DWR_NA0017_45_c_2013_45			
Action/Comments				
Inspector Comments: There is minimal vegetation within the channel, flow is not likely to be impeded.

View of vegetation downstream of Hwy 99. Summer 2019

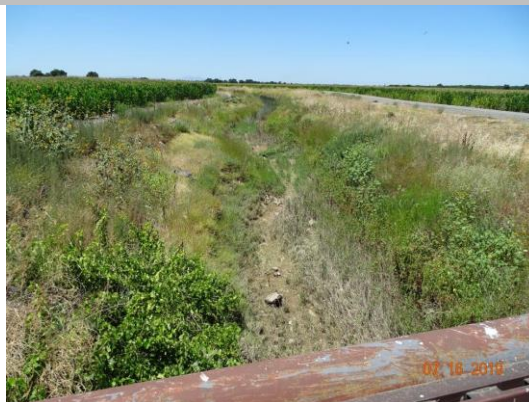
Photo 2 of 3 : CH_2019_NA0017_45_45_20190718_00050.jpg

View of vegetation looking downstream. Summer 2019

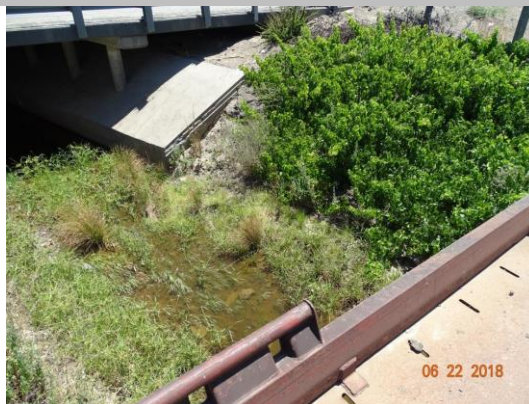
Photo 3 of 3 : CH_2019_NA0017_45_45_20190612_00020.jpg

Rating **	A	Issue No.	45 (cont)	GPS Lat/Long
Issue Type +	Ma	Location *		37.875127 °
Category	Rivers, Channels & Designated Flood			-121.219201 °
Item	Vegetation & Obstructions			
DWR ID	DWR_NA0017_45_c_2013_45			
Action/Comments				
Inspector Comments: There is minimal vegetation within the channel, flow is not likely to be impeded.

View of the channel looking downstream. Summer 2018

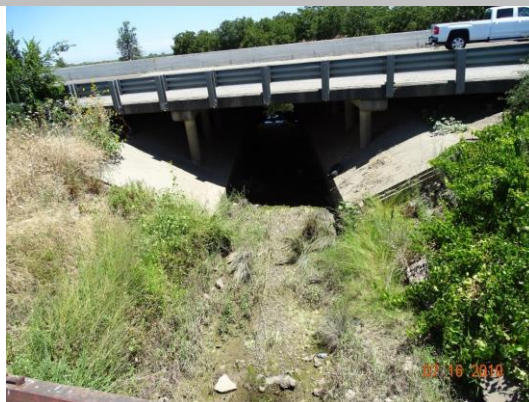
Photo 1 of 1 : CH_2019_NA0017_45_48_20190718_00051.jpg

Rating **	A	Issue No.	48	GPS Lat/Long
Issue Type +	Ma	Location *		37.875127 °
Category	Rivers, Channels & Designated Flood			-121.219201 °
Item	Revetments			
DWR ID	DWR_NA0017_45_c_2013_48			
Action/Comments				
Inspector Comments: Riprap is visible and appears to be undamaged.

View of revetments downstream of Hwy 99. Summer 2019
